The
San Francisco Earthquake and Fire

A BRIEF HISTORY OF THE DISASTER

A Presentation of Facts and Resulting Phenomena, with Special
Reference to the Efficiency of Building Materials
Lessons of the Disaster

A. L. A. HIMMELWRIGHT, C.E.

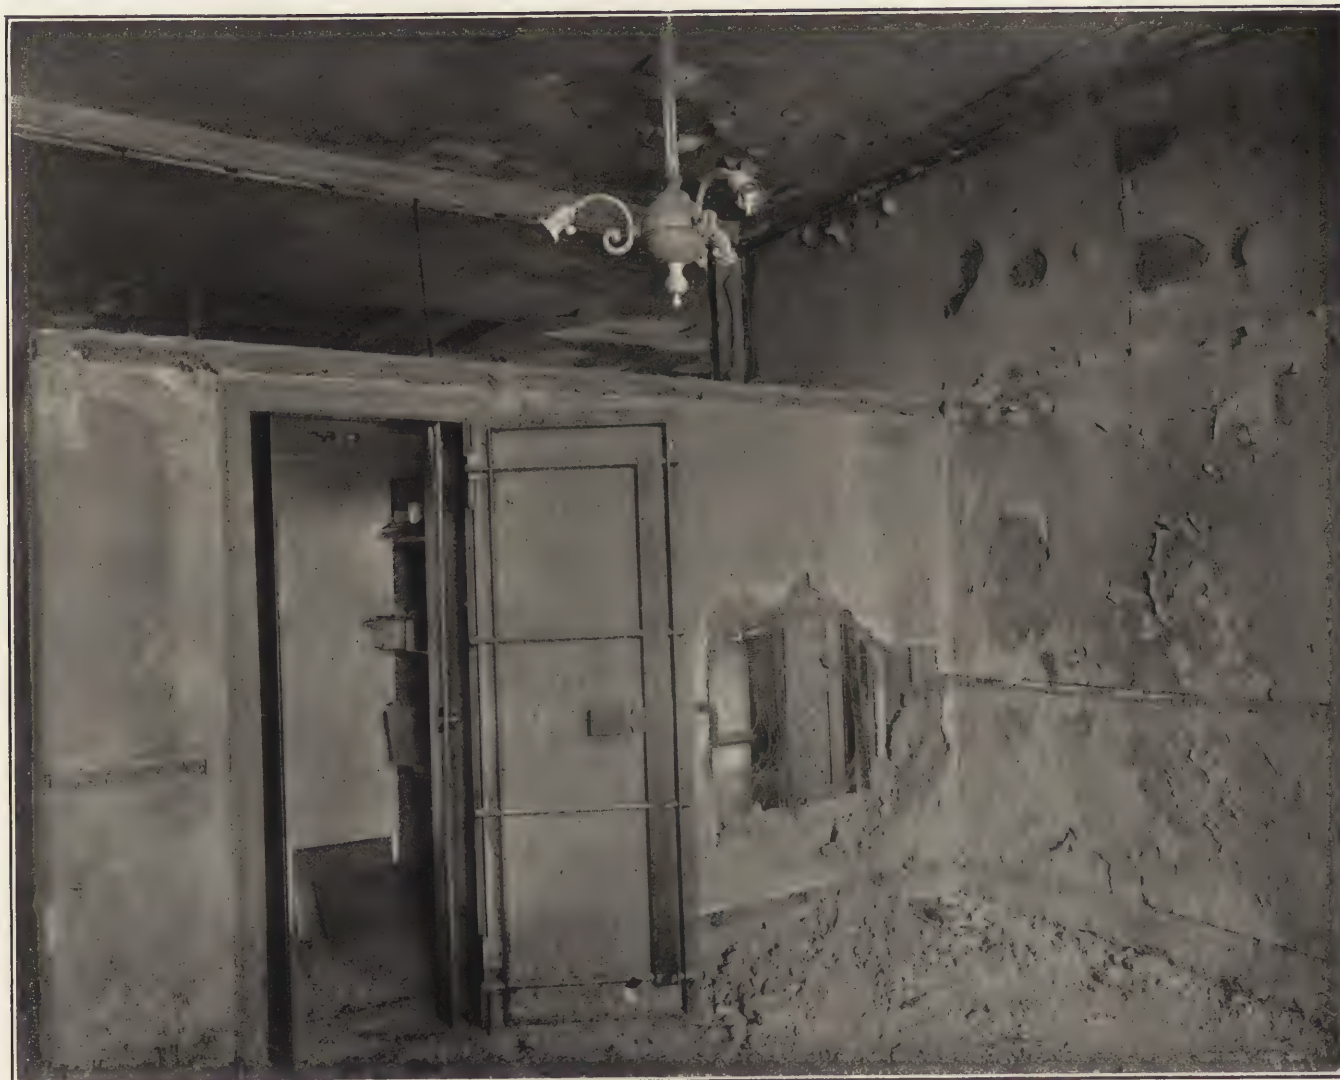
MERCHANTS' EXCHANGE BUILDING. Showing a Roebling vault, with double steel doors, which preserved its contents perfectly. The walls and top are of solid concrete; the studs of $2'' \times \frac{1}{8}''$ flat steel are spaced $16''$ on centres. Roebling $\frac{1}{4}''$ solid rod stiffened wire lath is applied to both sides of the studs, and the space between the wire surfaces is filled solid with cinder concrete. The plaster is then applied to both sides, making a total thickness of 4 inches. The handles of the combination lock of this vault fused, and it was impossible to open the door. The hole through the wall of the vault in the centre foreground was made in order to get at the contents, and shows the details of the construction. There were no cracks in the walls or top of this vault.

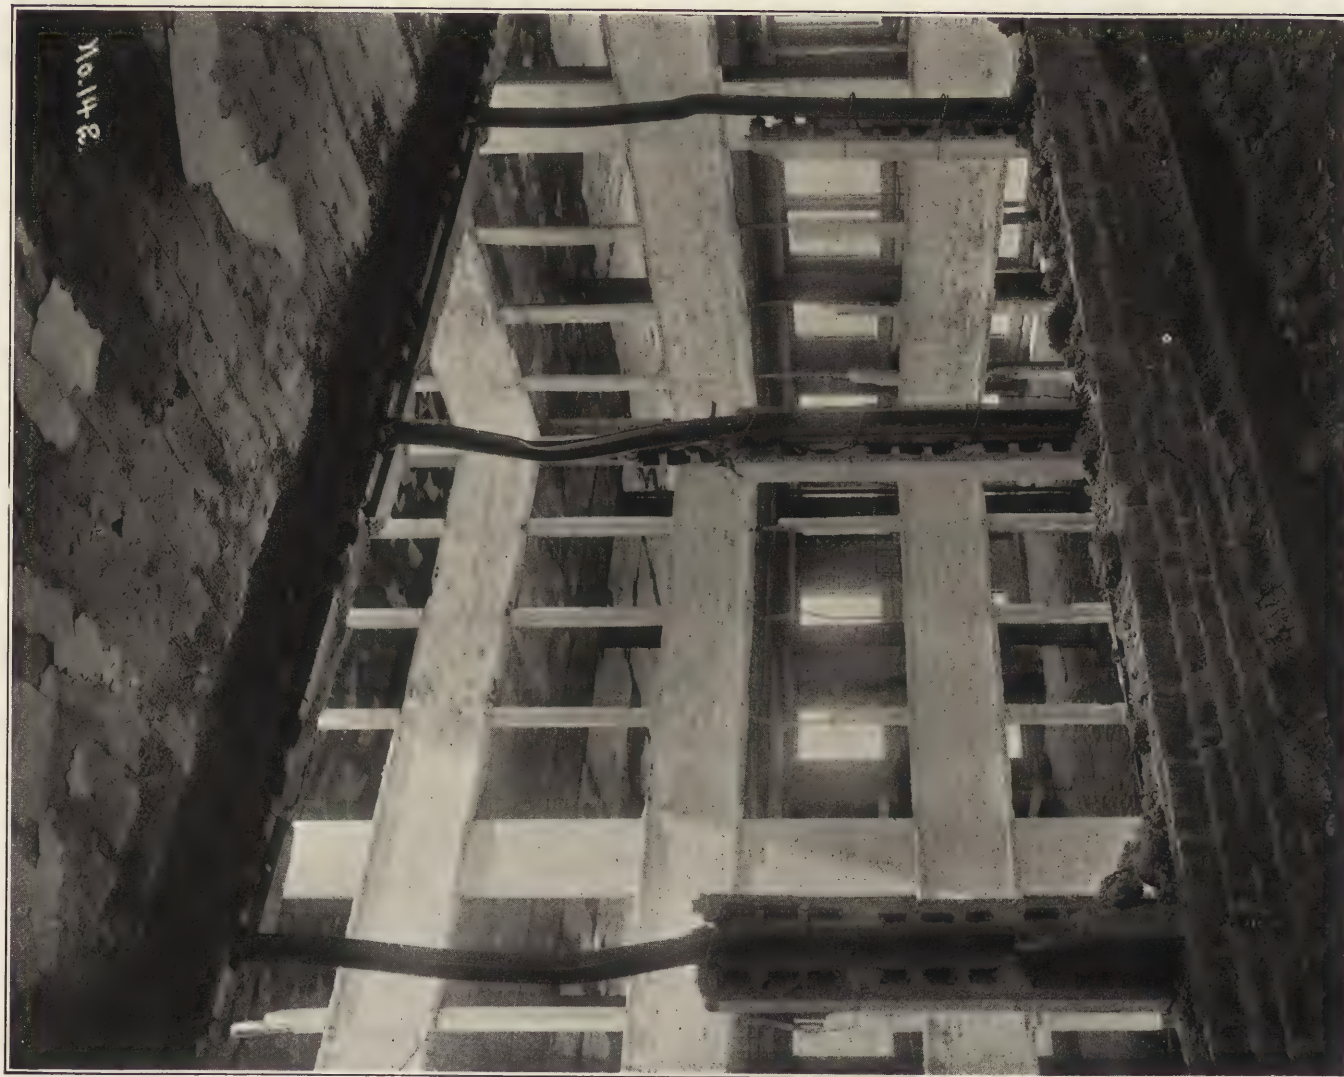
MERCHANTS' EXCHANGE BUILDING. Eighth Story. Showing the buckled and distorted steel supports for mullions. These steel members were rigidly connected top and bottom, no provision having been made for expansion. The buckling and distortion of these members disrupted the terra cotta facing, which fell down breaking the glass and seriously damaging the skylight at the bottom of the light court. The view shows also the distortion of similar steel members on the other side of the court.

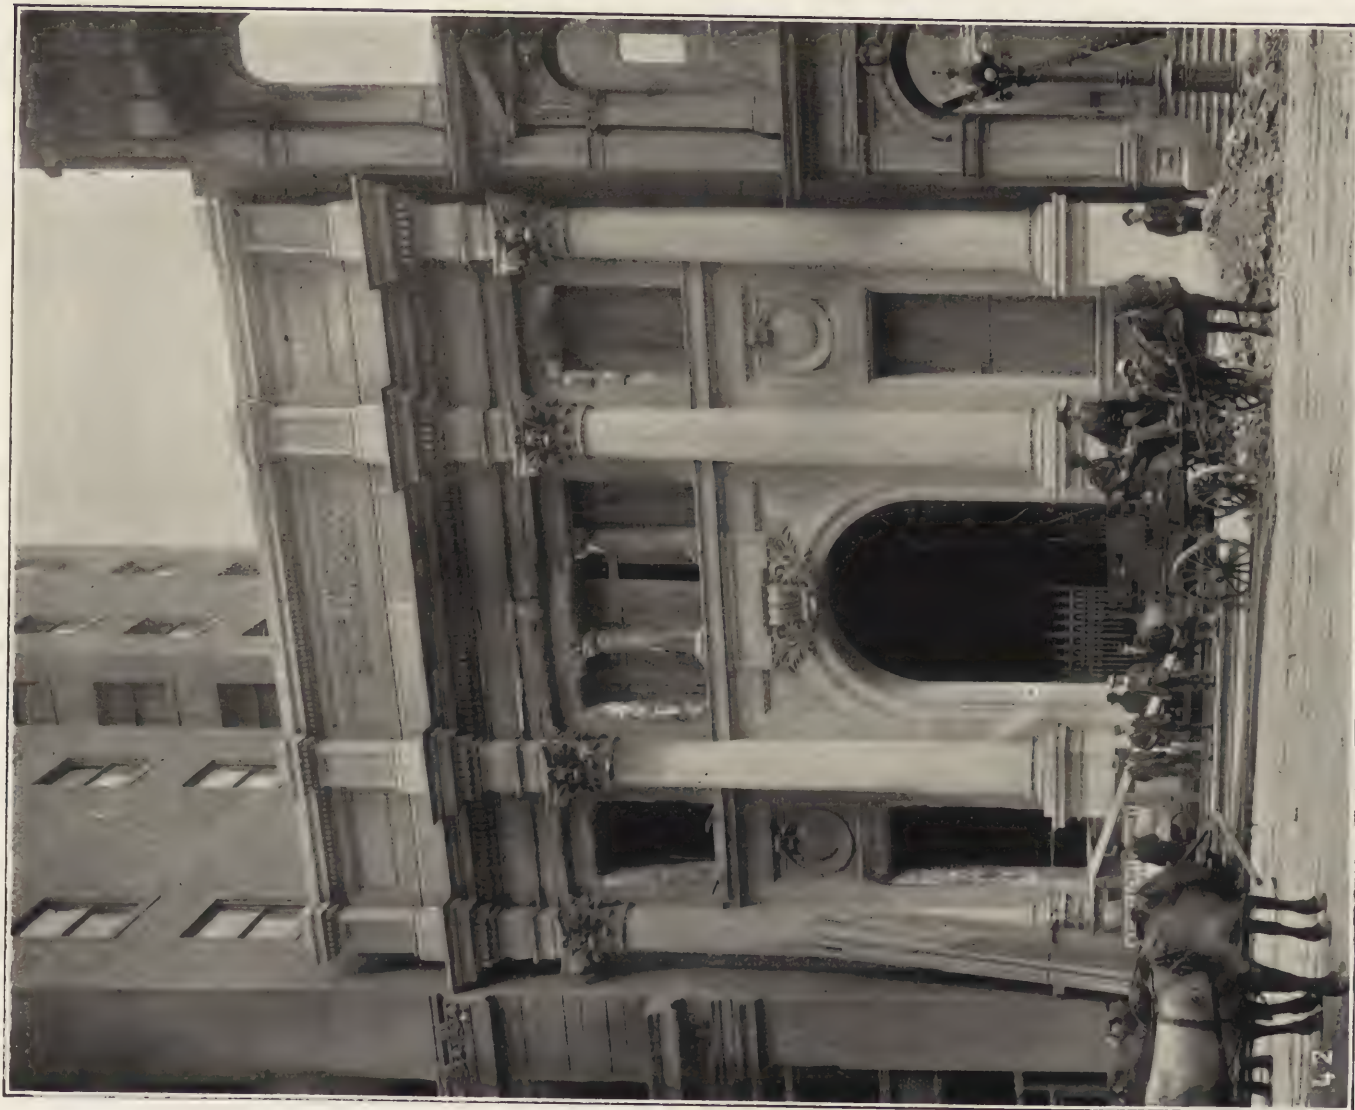
MERCANTILE TRUST CO.'S BUILDING. North Side of California Street between Montgomery and Sansome Streets. The façade consists of gray granite, which is considerably damaged by spalling around the window openings. The building is structurally uninjured. The fire-proof floors are segmental stone concrete arches. The roof consists of the Roebling system B flat cinder concrete slab. The partitions are of double wire lath and plaster. This building was occupied, pending permanent repairs, a few days after the fire.

The granite front of the building at the second story window openings and the west window opening of the first story, are badly spalled by the fire. Falling *débris* from the adjoining buildings at the time of the earthquake broke holes in the metal frame and wire glass skylight dome over the banking room. The combustible wood finish and furniture made a fire of considerable magnitude in the main banking room. A hot fire also occurred in the third story front room, which was of sufficient intensity to melt the wire glazing in a metal frame skylight in the roof over this room.

This building is structurally uninjured, and the damage to the front and the interior can be repaired.

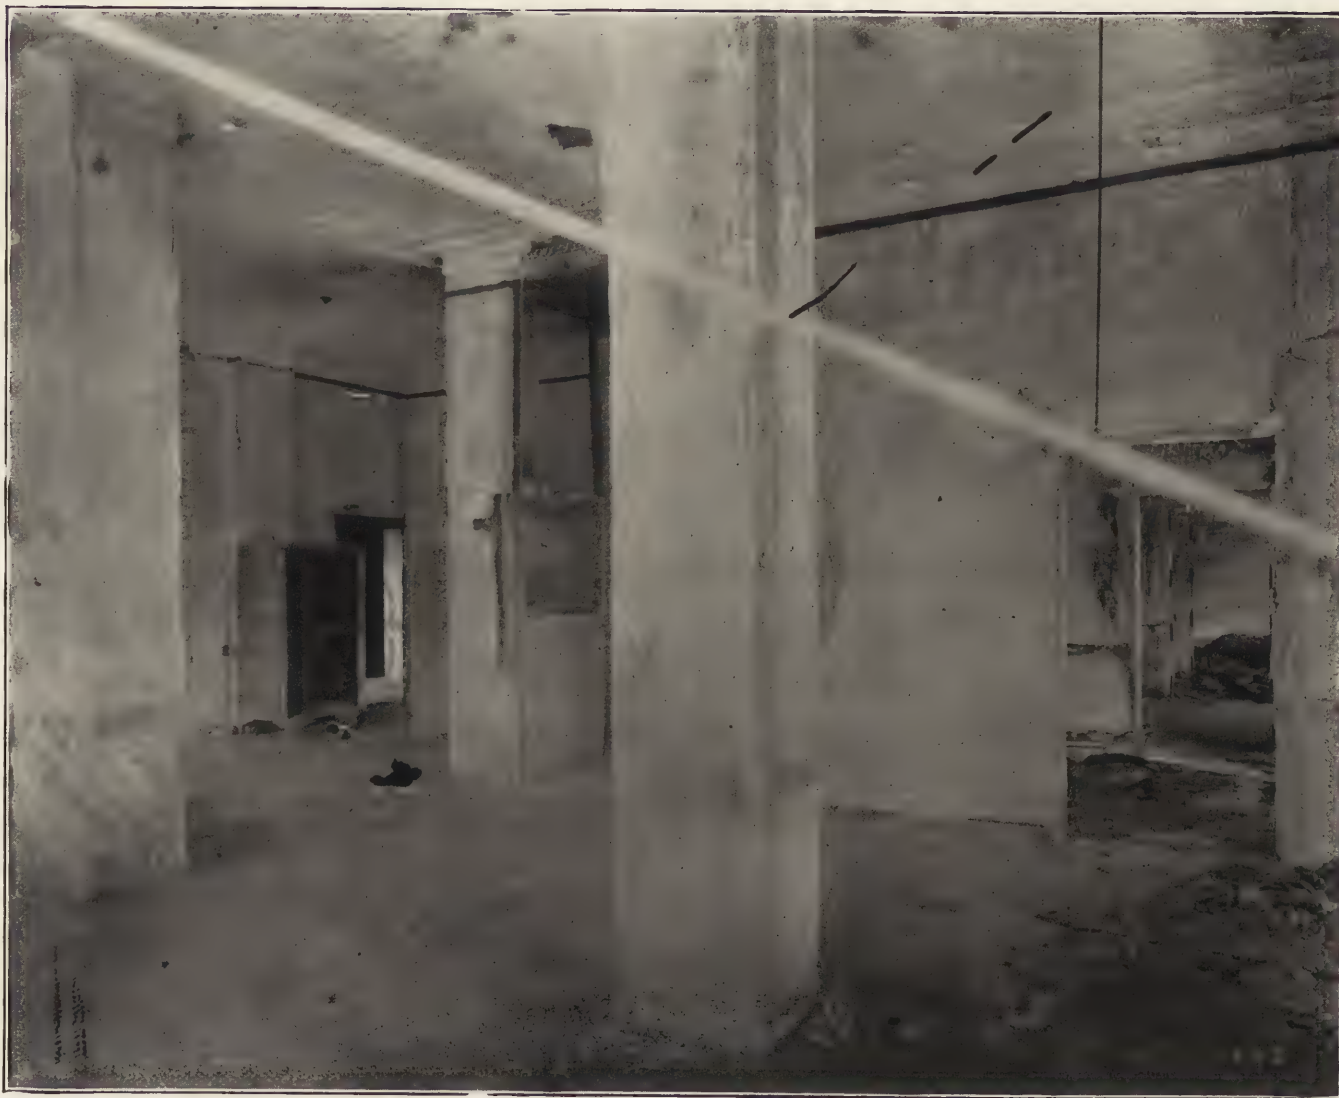
KOHL BUILDING. Typical view of the condition of the partitions in the portion of the building damaged by fire. The column protection was of double metal lath and plaster. The partitions were of the 2" solid metal lath and plaster type, and the doors and all the trim were of metal-covered wood.

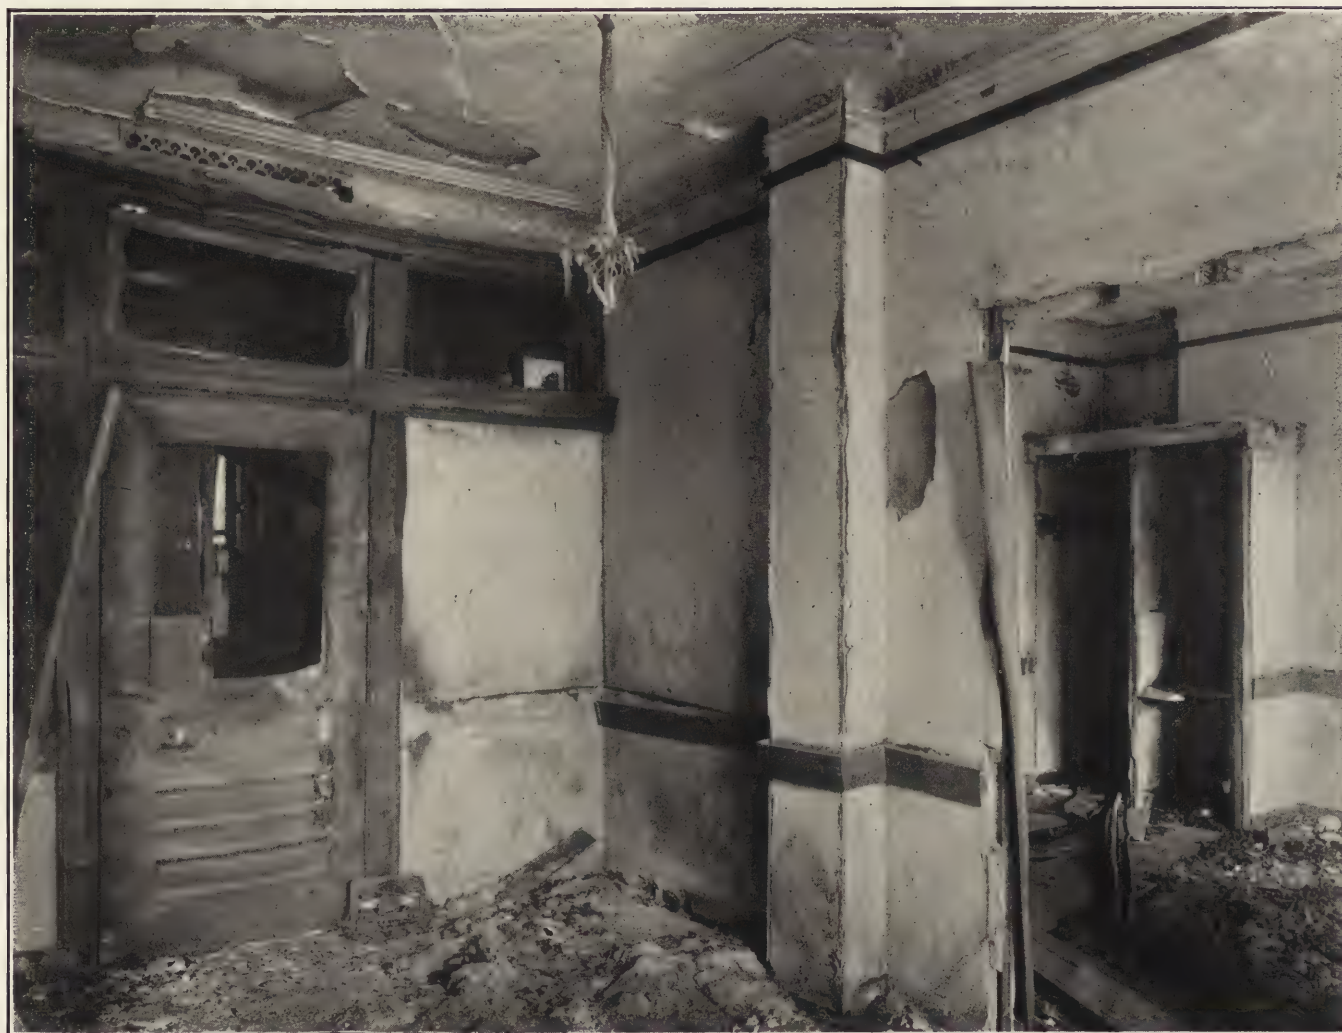
KOHL BUILDING. Typical view of the portions damaged by fire. The metal-covered doors, trim, etc., retarded the fire and prevented its spread in many parts of the building. The floors are of the expanded metal concrete type with a cement finish.

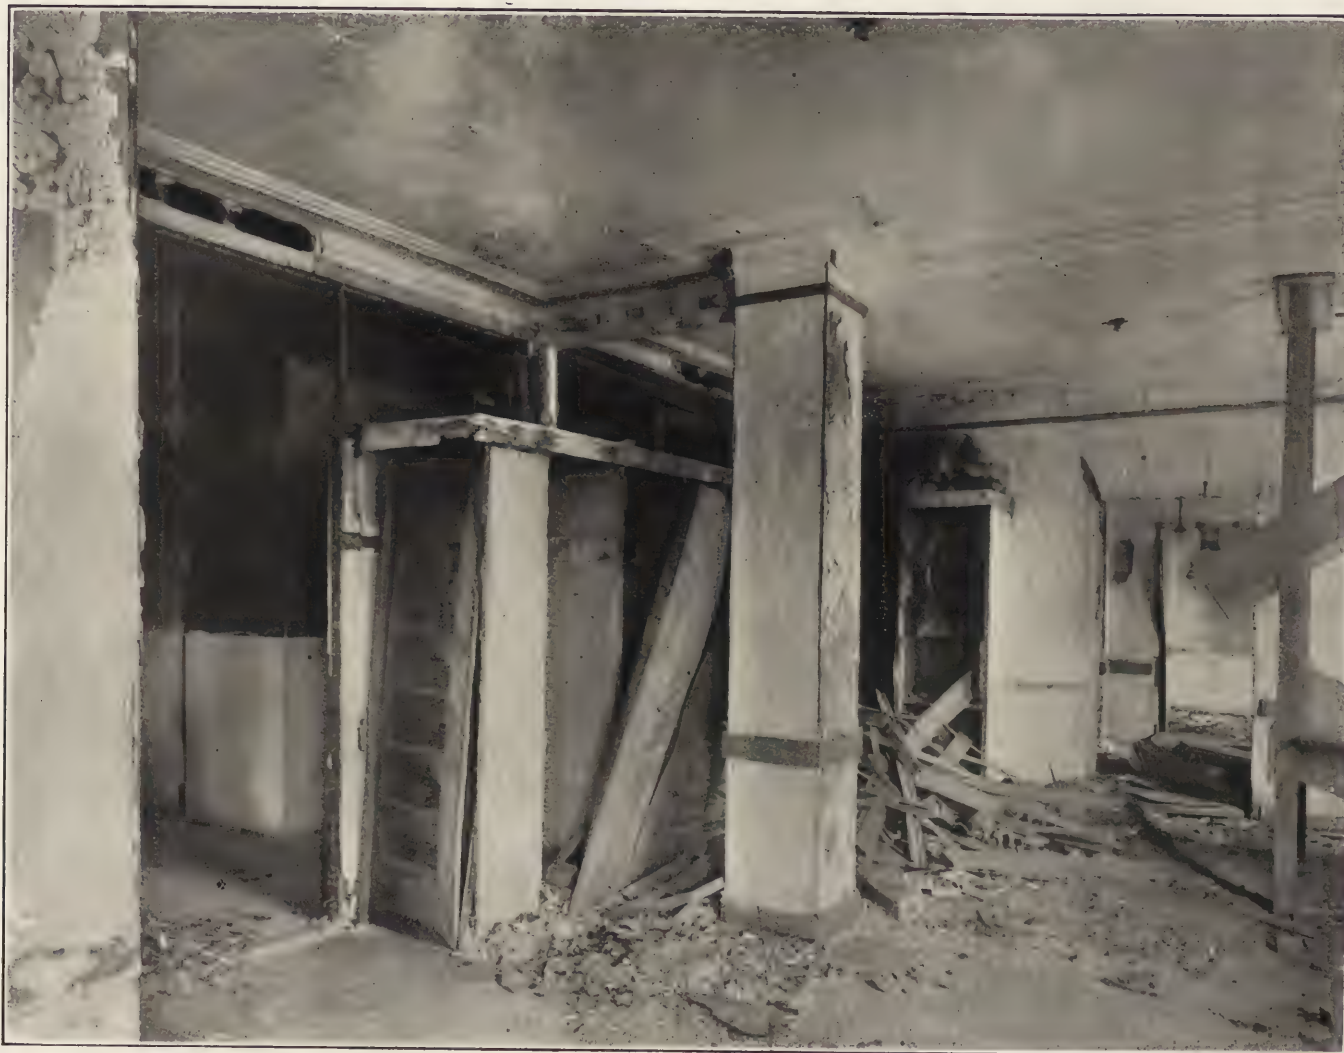
KOHL BUILDING. Typical view of the small damage to this building by fire. The concrete floors are finished in cement and are but little damaged in the parts subjected to fire.

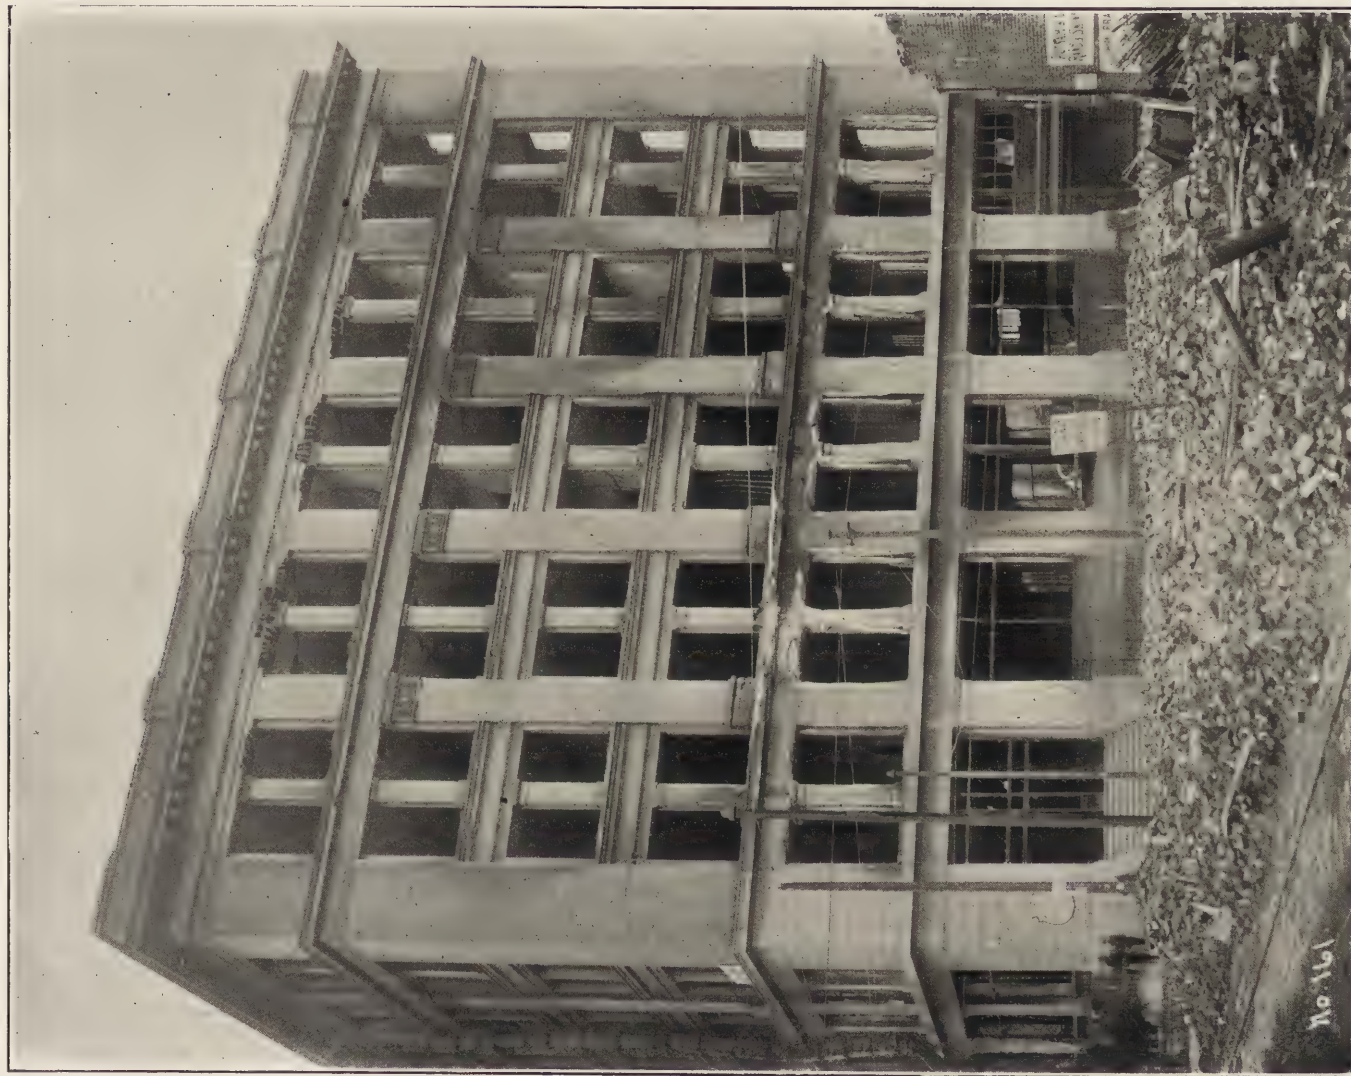
WELLS-FARGO BUILDING. Northeast Corner Mission and Second Streets. Showing the Mission Street front. The granite of the two lower stories is considerably spalled by the fire. The terra cotta brick piers at the fourth story level have characteristic earthquake cracks. The terra cotta projecting course at the sixth floor level is considerably cracked, and the window heads of this story are badly spalled. The Second Street front is much less damaged, and is in good condition. The metal frame is uninjured. The concrete floors remain in good condition. The wire lath ceilings remain in place, but the plaster is badly cracked throughout by the earthquake. All the double wire lath and plaster partitions remain standing, but a few of them are out of plumb.

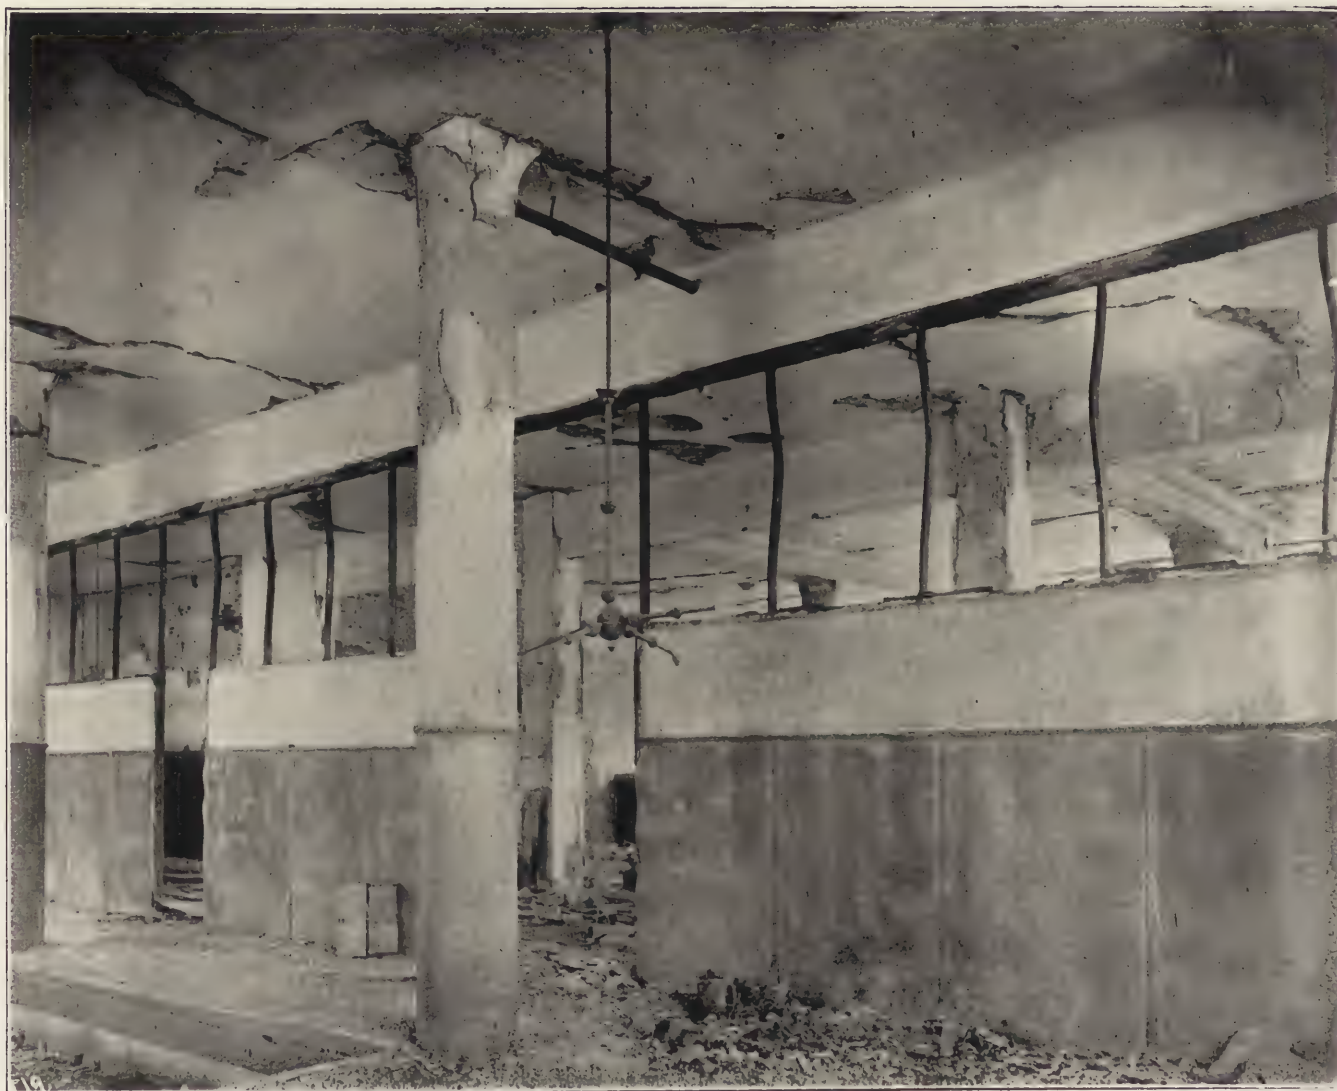
WELLS-FARGO BUILDING. First Story. Showing 4" hollow metal lath and plaster partitions (with large sash light openings) remaining in position, and the earthquake cracks in the lath and plaster ceiling. The metal lath and plaster column protection is but slightly damaged.

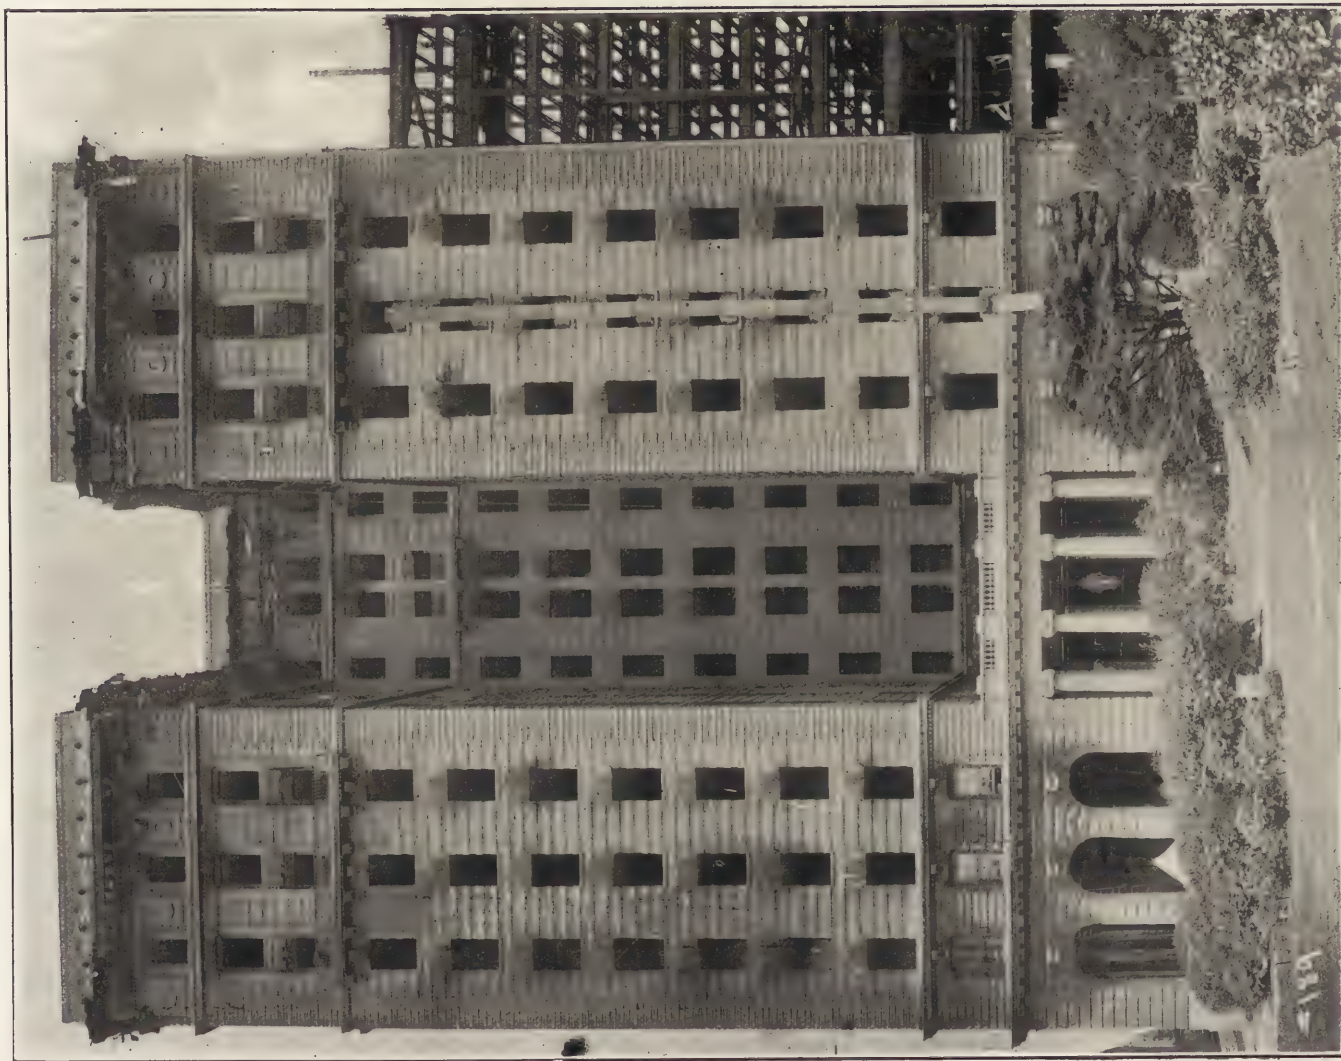
HOTEL ST. FRANCIS. Northwest Corner Powell and Geary Streets. The façades, consisting of a granite base and gray sand-stone above, are in good condition, a few window openings only being slightly spalled by the fire. The metal cornice is completely wrecked. The west light court was entirely stripped of the enamelled face brick from top to bottom. With the exception of two columns in the mezzanine story, which are deflected out of plumb, the steel skeleton frame is uninjured. The Roebing segmental concrete floors and wire lath and plastered ceilings remain in first-class condition. The Roebing concrete column protection in the large dining rooms is uninjured, but the 4" hollow tile protection elsewhere is damaged in spots. The 4" hollow tile partitions are cracked and damaged, and about 15 per cent. of the blocks have fallen down. The good quality of the materials and workmanship have shown to good advantage, this being one of the least injured buildings structurally that passed through the earthquake and the fire. The illustration shows about one-half of the width of the new annex of similar construction.

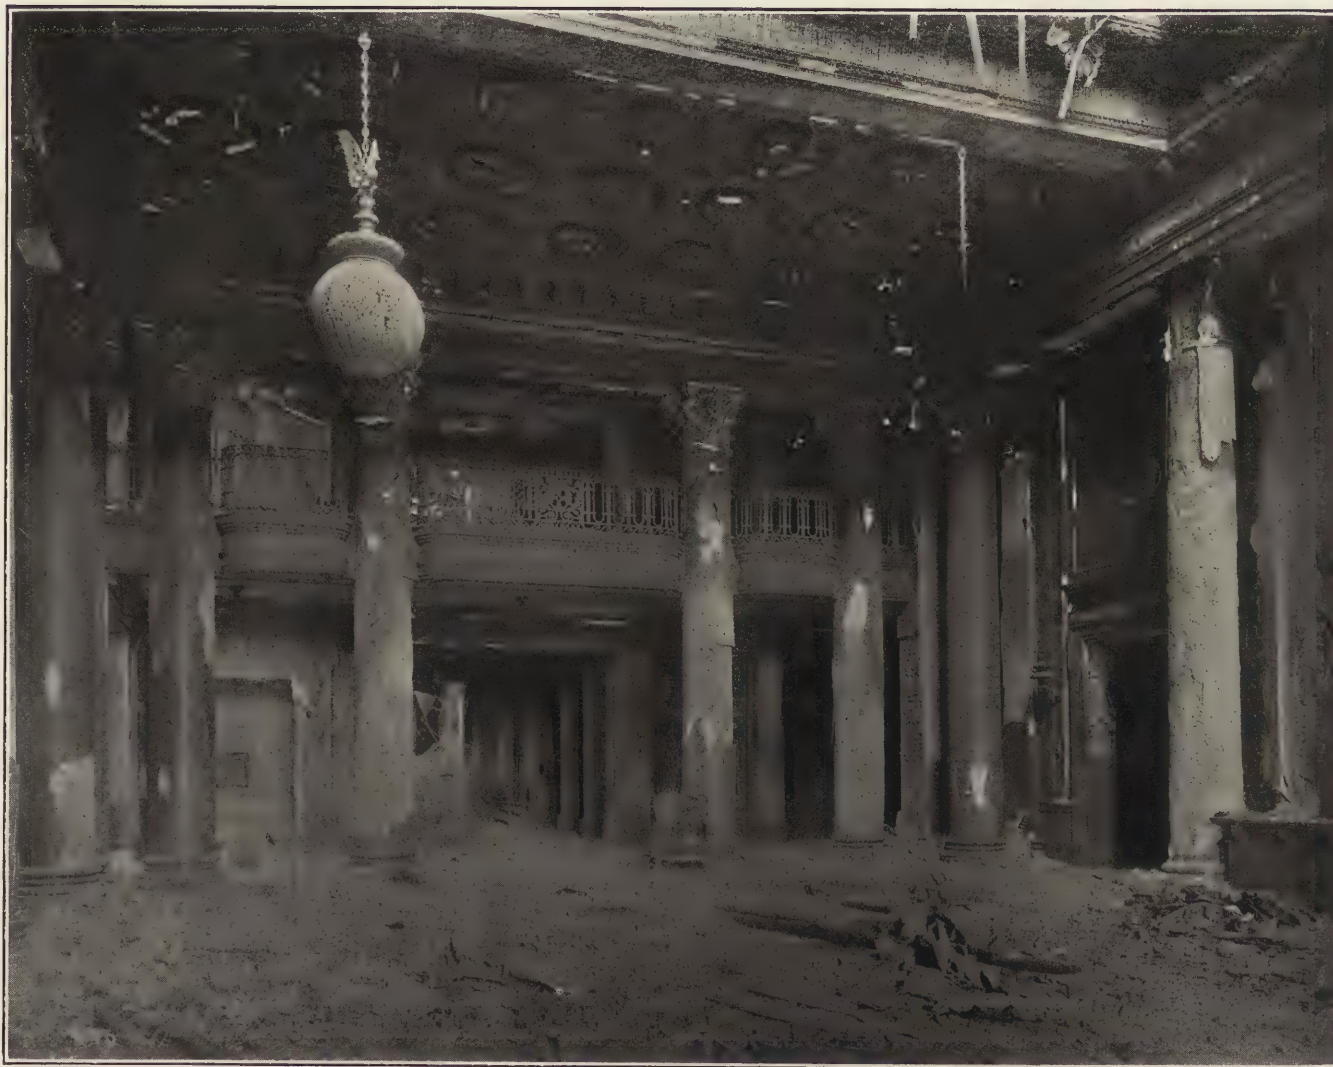
HOTEL ST. FRANCIS. Interior of the main lobby, looking from the entrance. The ornamental effects were produced by the Roebling method of light steel furring and wire lathing. The plaster caps were cast and are badly damaged. The columns are protected with cinder concrete, a defect in the design showing on the right-hand side where the protection was omitted behind the cap near the top. This portion of the building was subjected to a very moderate fire.

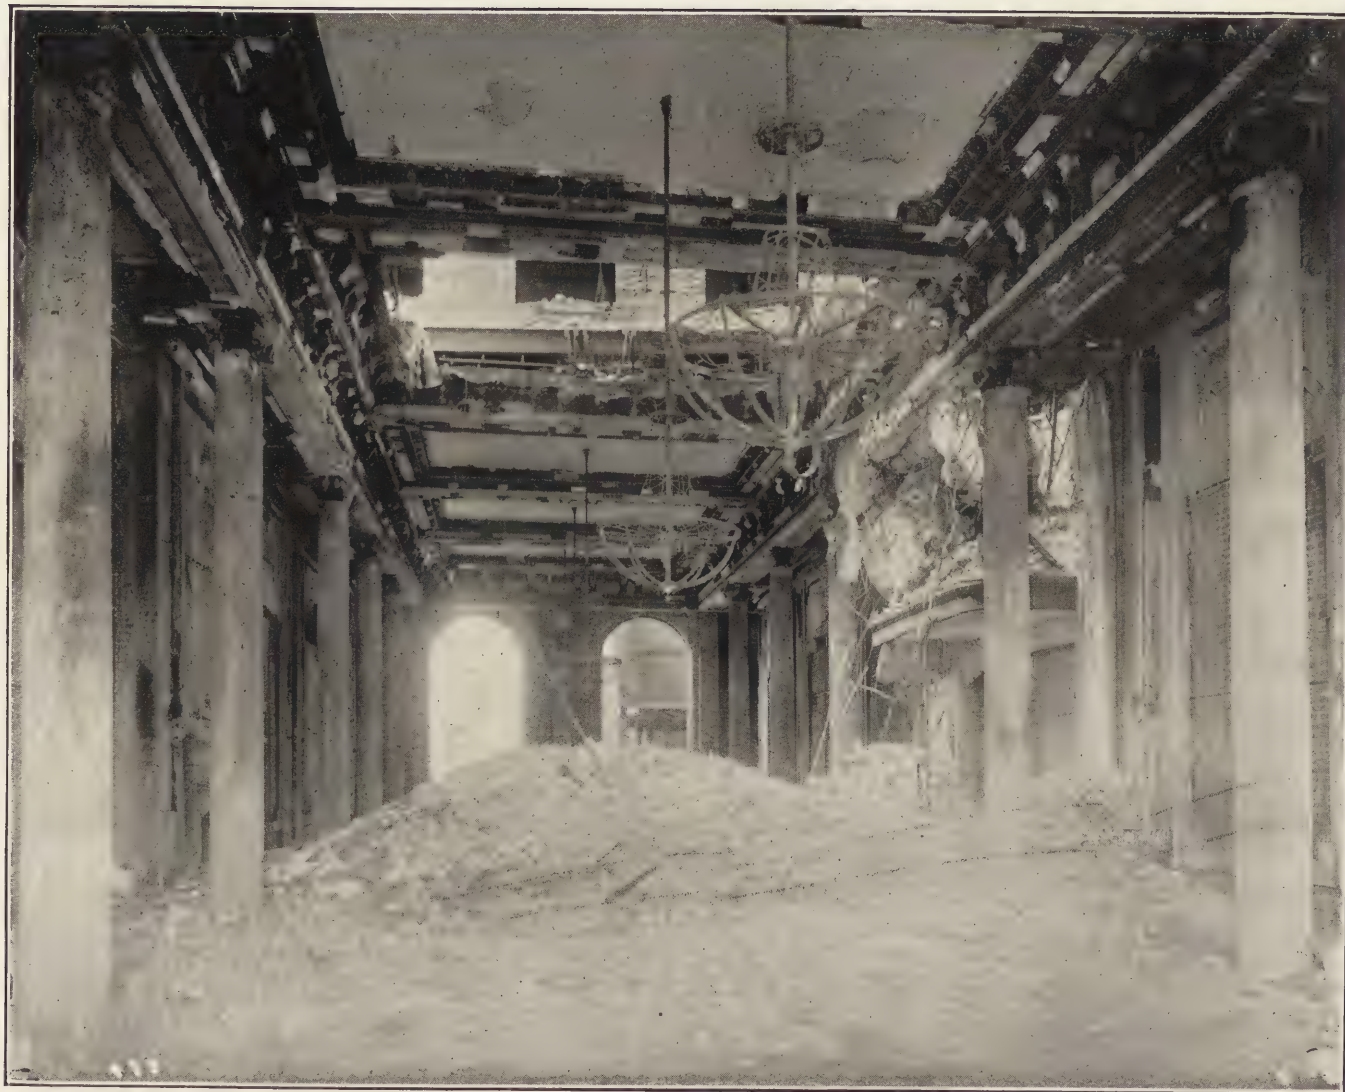
HOTEL ST. FRANCIS. First Story. The fire broke the bond of the face brick of the light court located directly over the centre of one of the dining-rooms, causing the face brick to fall through the skylight to the floor of the dining-room, where they formed a huge pile, as shown. The Roebling segmental concrete arches successfully resisted the impact of the falling brick, sustaining the enormous load without injury until it was removed. The columns in this story were concreted by the Roebling method. Note the mistake of omitting the column protection near the ceiling line, where ornamental plaster caps were placed.

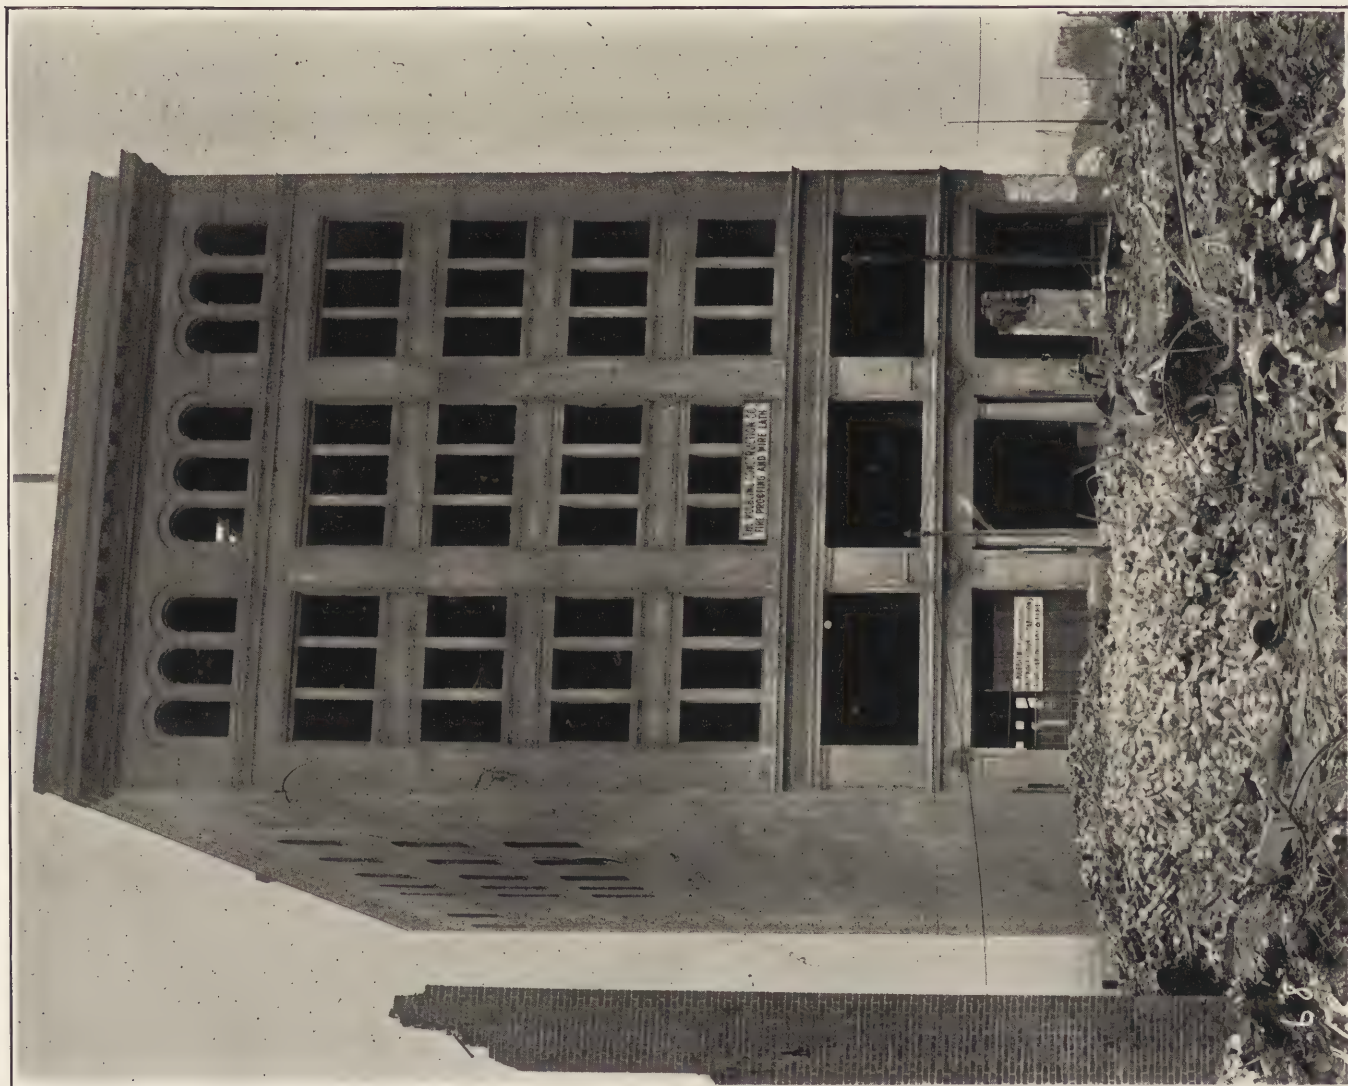
CALIFORNIA CASKET CO.'S BUILDING. Mission Street between Fifth and Sixth Streets. The facade consists of Colusa sandstone. This building was in the course of construction and was only slightly damaged by the fire. The sandstone is spalled and cracked in spots, but the front is comparatively little damaged. The steel skeleton frame and the Roebbling concrete floors and column protection are uninjured. The brick vaults, with 13" walls that were built in each story, were also more or less damaged by the earthquake.

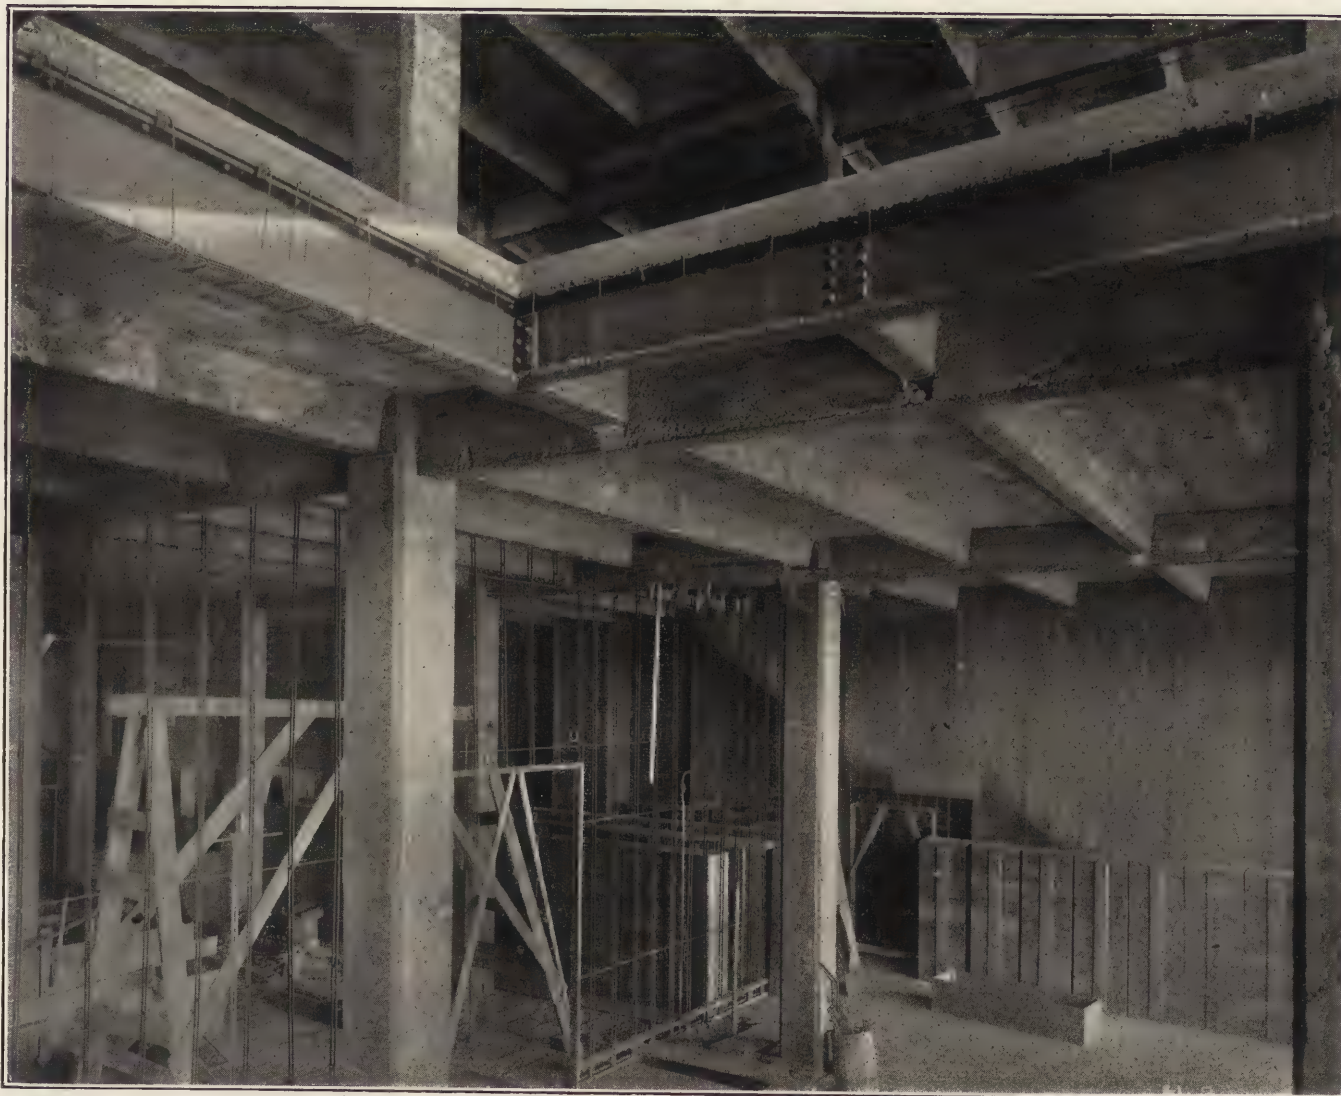
CALIFORNIA CASKET CO.'S BUILDING. First Story. Showing the finished concrete column protection, and the crimped galvanized lath on the soffits of the beams and girders and the exterior wire wall furring ready for the plaster. This building was in the course of construction at the time of the fire and had little combustible contents. All the wood work, such as window frames, scaffolding, etc., was consumed. The merchandise, trestles, etc., shown in the photograph, were carried into the building after the fire.

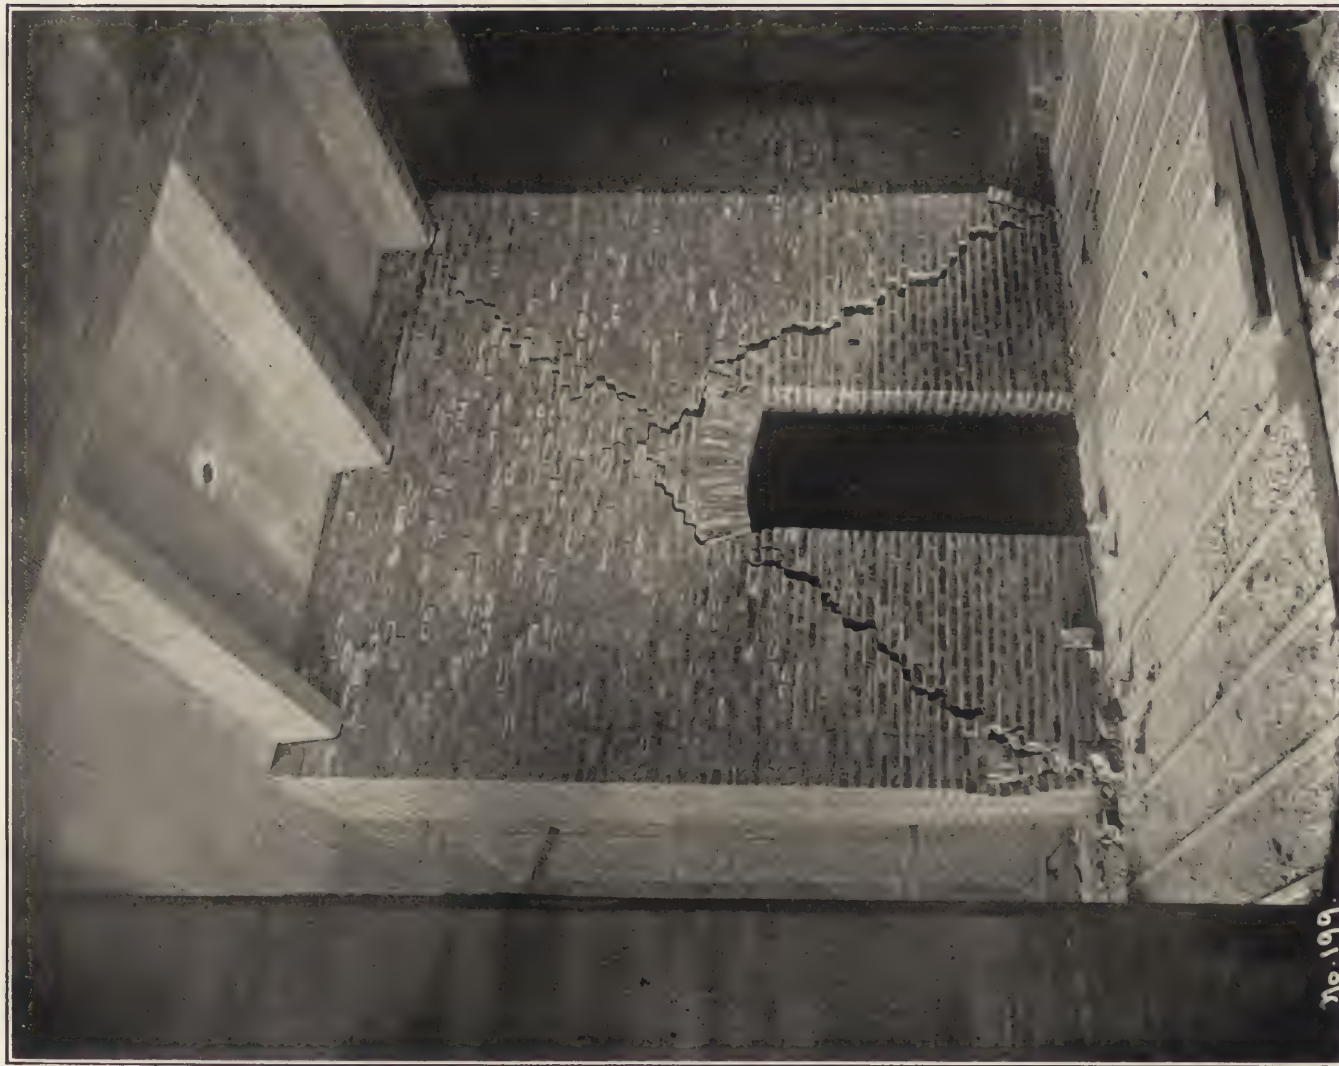
CALIFORNIA CASKET CO.'S BUILDING. Second Story. Showing the earthquake damage to a brick vault built between the Roebling concrete floors. A similar vault on the first floor was completely destroyed. In the upper stories, the vaults were similarly but less damaged by the earthquake. The Roebling crimped wire is in position on the soffits of the beams and girders ready to receive the cement plaster. The column at the left-hand side is protected with concrete by the Roebling method.
